THAMES RIVER BASIN
NORWICH, CONNECTICUT
SPAULDING POND DAM
CT 00202

SPAULDING POND DIKE
CT 01685

PHASE I INSPECTION REPORT
NATIONAL DAM INSPECTION PROGRAM

AUGUST, 1980

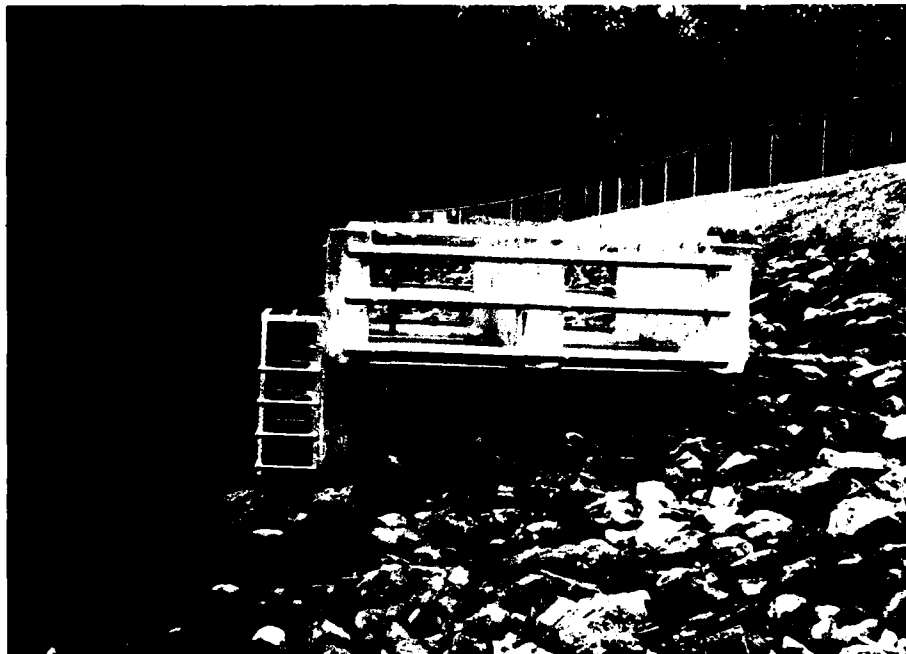
Upstream Slope - The upstream slope is in good condition (Photo 1). No significant displacement of riprap was observed. Grass cover on the upper portion of the slope appears good except at the very top of the slope where the grass has been mowed very short and is burned.

Spillways - The principal spillway is in good condition, with no signs of any cracking, spalling or other deterioration of the concrete (Photo 1).

It was noted that while the design length of the principal spillway is 15 feet, its effective length is only 13 feet due to the concrete trash rack support (Photo 1).

Photo 1 - Principal spillway structure and upstream slope of dam (6/2/80).
